Restoration and Meadow Emergence

History 1939 - Reach 6 Aerial Photo

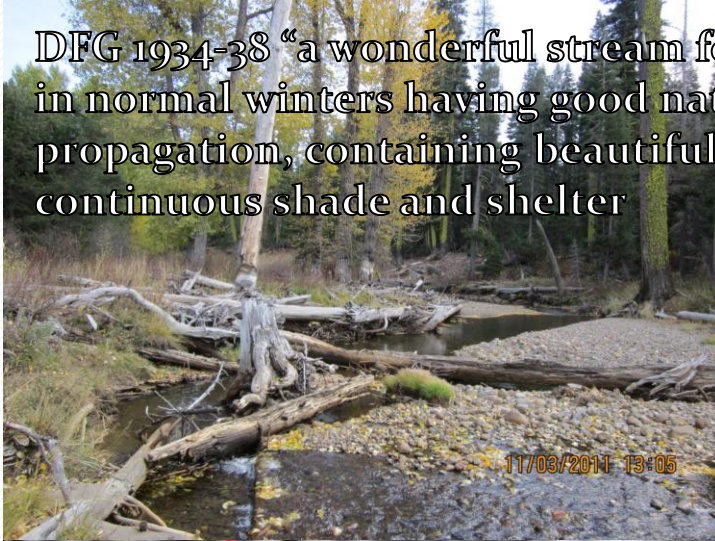
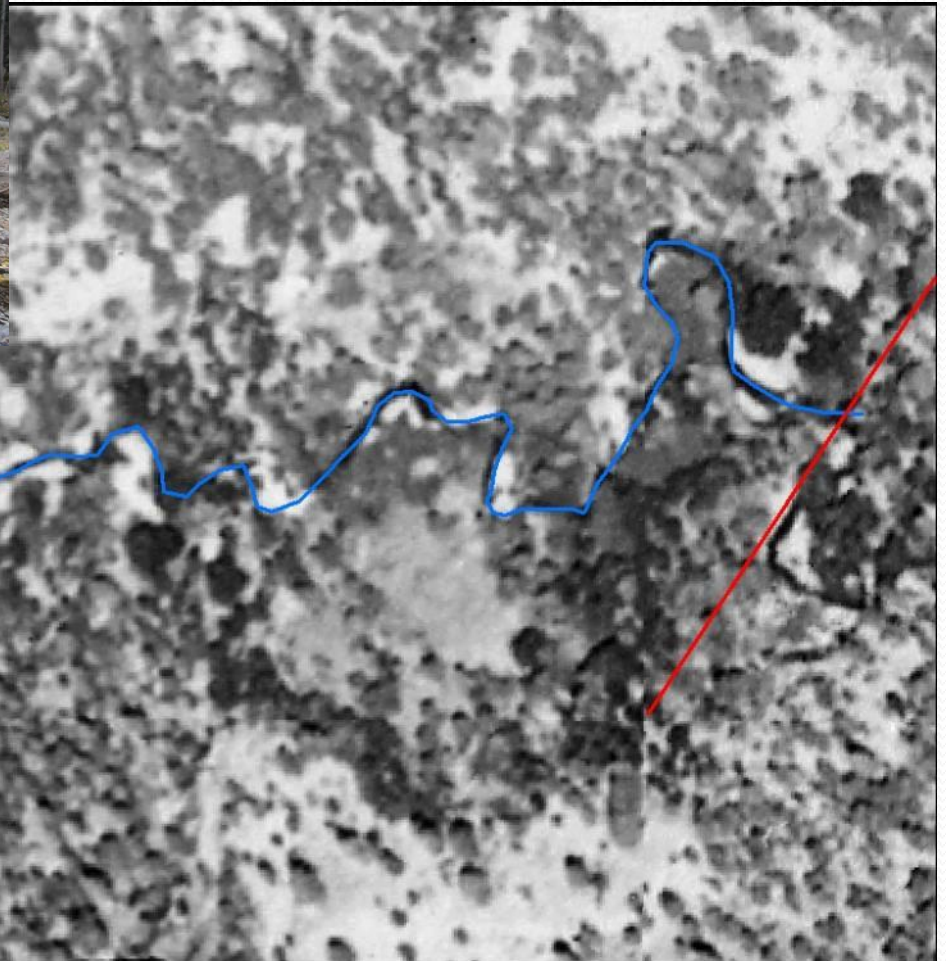
A little narrow stream wandering through a cottonwood forest...

DFG 1934-38 "a wonderful stream for spawning in normal winters having good natural propagation, containing beautiful pools, continuous shade and shelter

Year	Channel Length (m)	Sinuosity
1939	985	1.80
1969	894	1.63
1986	835	1.53
1995	777	1.42
2001	731	1.34
2007	674	1.23

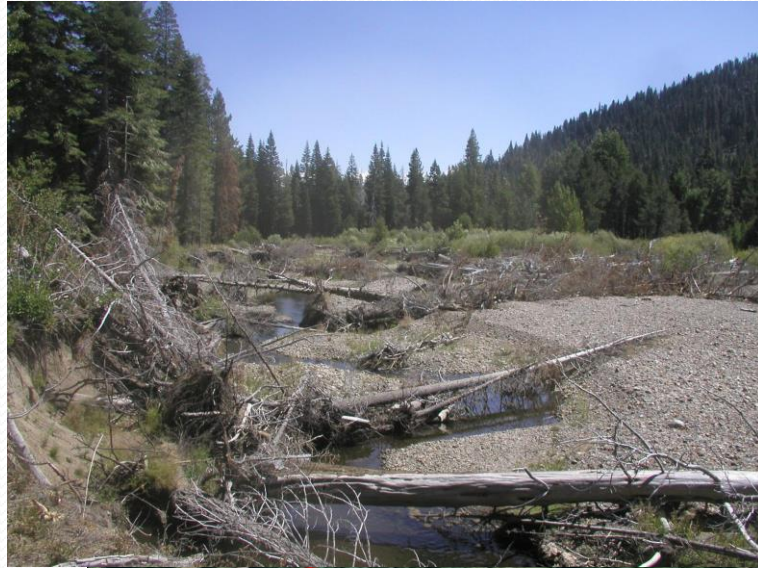
History - 2007 Reach 6 Aerial Photo

Little or none of the old stream left...or floodplain...

Year	Channel Length (m)	Sinuosity
1939	985	1.80
1969	894	1.63
1986	835	1.53
1995	777	1.42
2001	731	1.34
2007	674	1.23

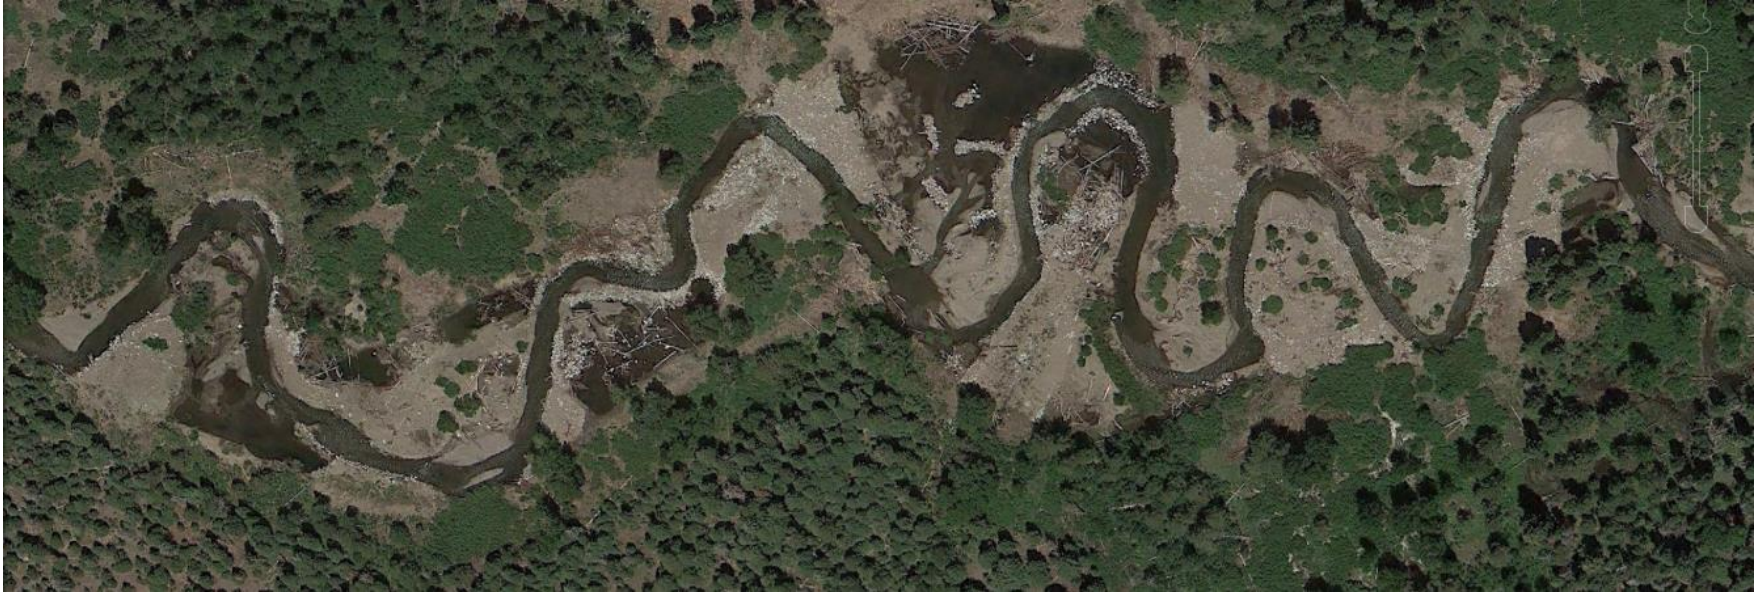
2010 post construction

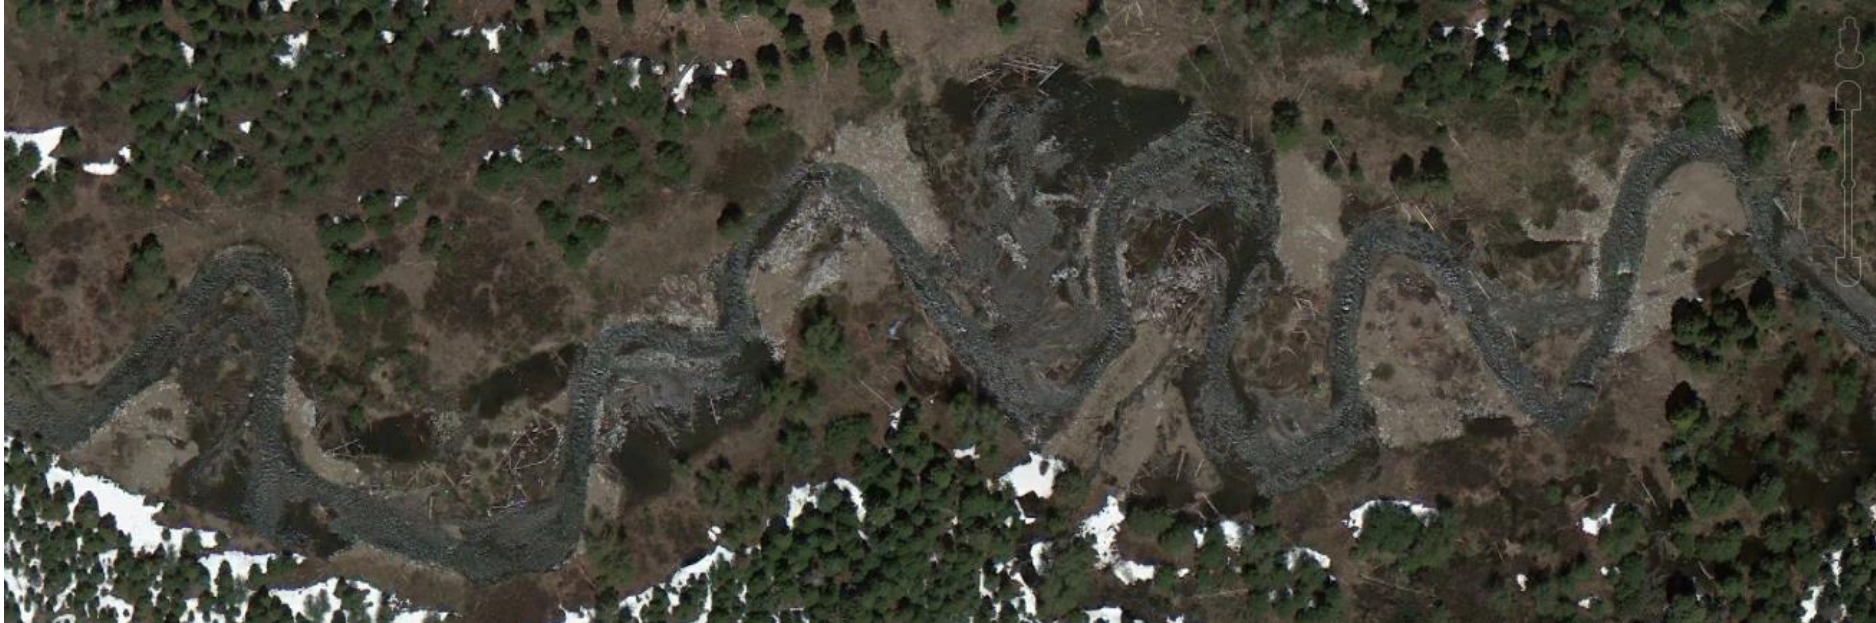
2011 post construction

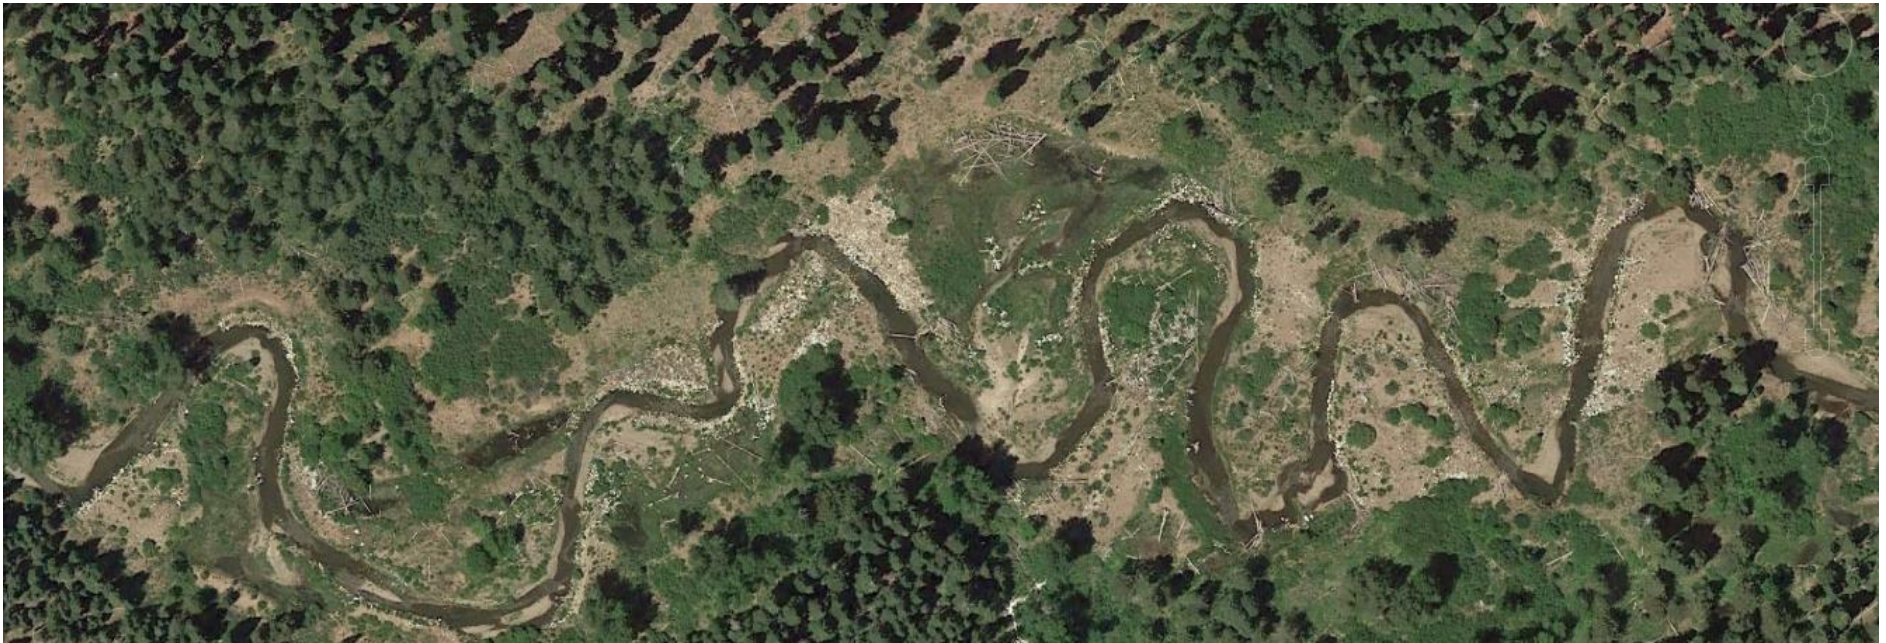
2016 post construction

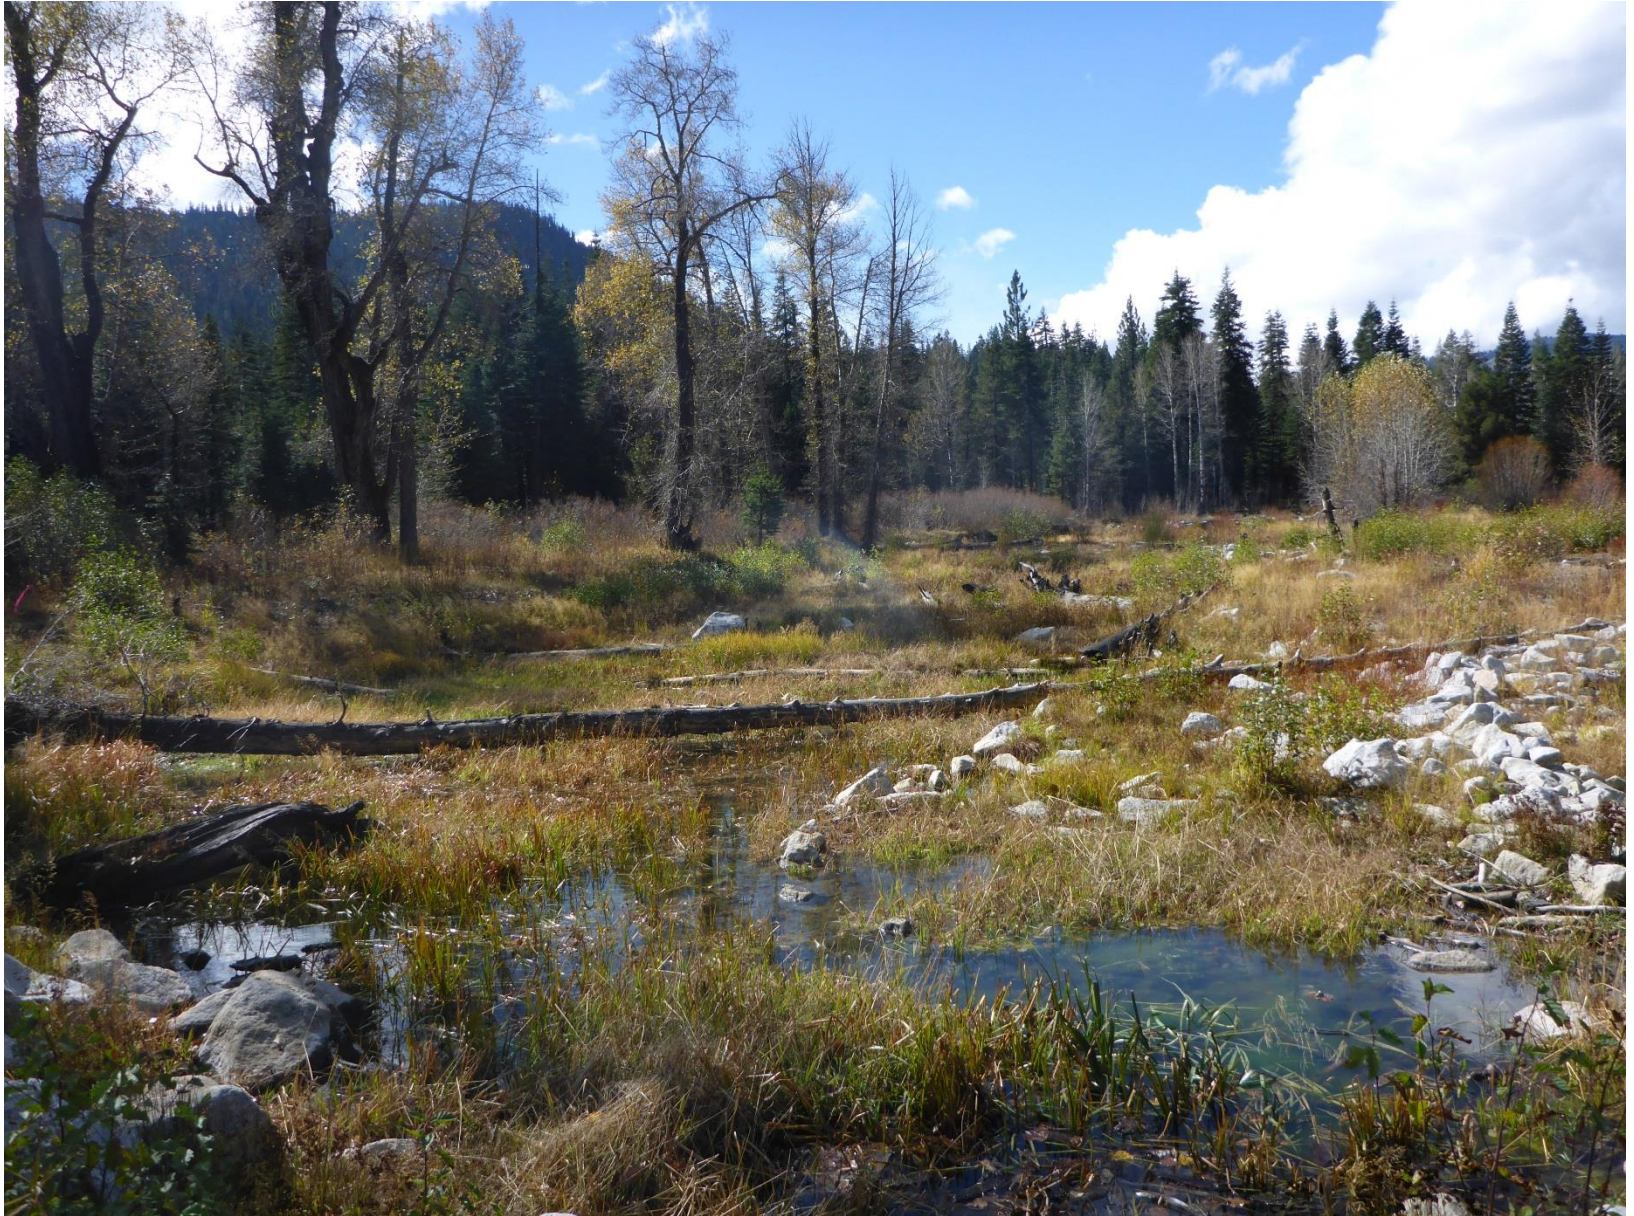
2015 Emerging meadow area downstream of a roughness structure
